HAZARDOUS MATERIALS SURVEY FINAL REPORT

Center Joint Unified School District Office Annex 3243 Center Court Lane Antelope, CA 94843

Entek Project #24-7184

April 29, 2024

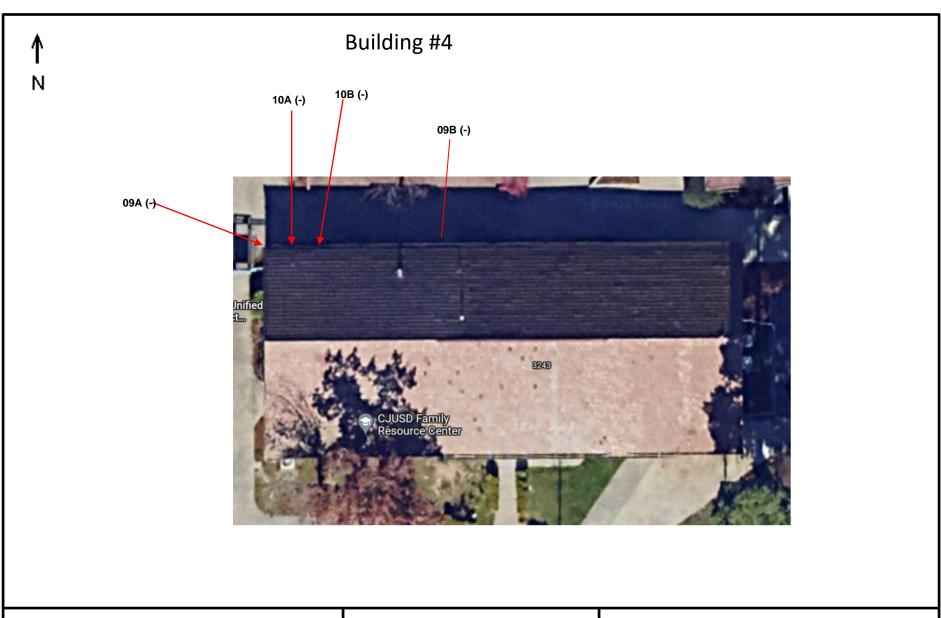
Asbestos Bulk Sample Locations Collected by ---Gerald Moralez On Date –April 24, 2024 Project Number 24-7184

The attached drawing shows approximate sample locations and also identify those bulk sample materials analyzed and found to contain asbestos greater than 1% with a (+) after the sample number. Materials analyzed and found to contain less than 1% asbestos or reported as none detected have a (-) after each sample number. However, in some cases when several samples of one homogenous material are collected, sometimes not all samples are analyzed by the laboratory. In this instance, if one sample for a homogeneous material is reported as containing asbestos greater than 1%, then the remaining samples in the series that are not analyzed are assumed to contain asbestos greater than 1%. For the purposes of this report, all samples that were not analyzed in a series are assumed to contain asbestos greater than 1% and are identified on the attached drawing with a (+) after the sample number.

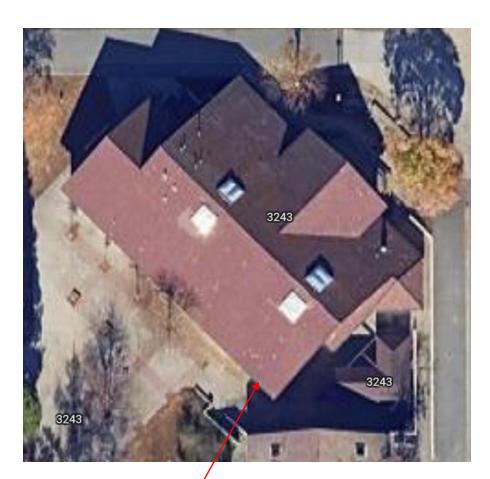
Lead Bulk Sample Locations Collected by ---Gerald Moralez On Date –April 24, 2024 Project Number 24-7184 Ψ

• Metal Flashing - *Results ranged between 957,468 to 961,051* ppm – *Around all pipes, vents*, and potential HVAC associated.
